Onkaparinga Waterwatch Snapshot 1

Northern Coastal catchments
Incorporating: Waterfall Creek, Field River,
Christie Creek catchments

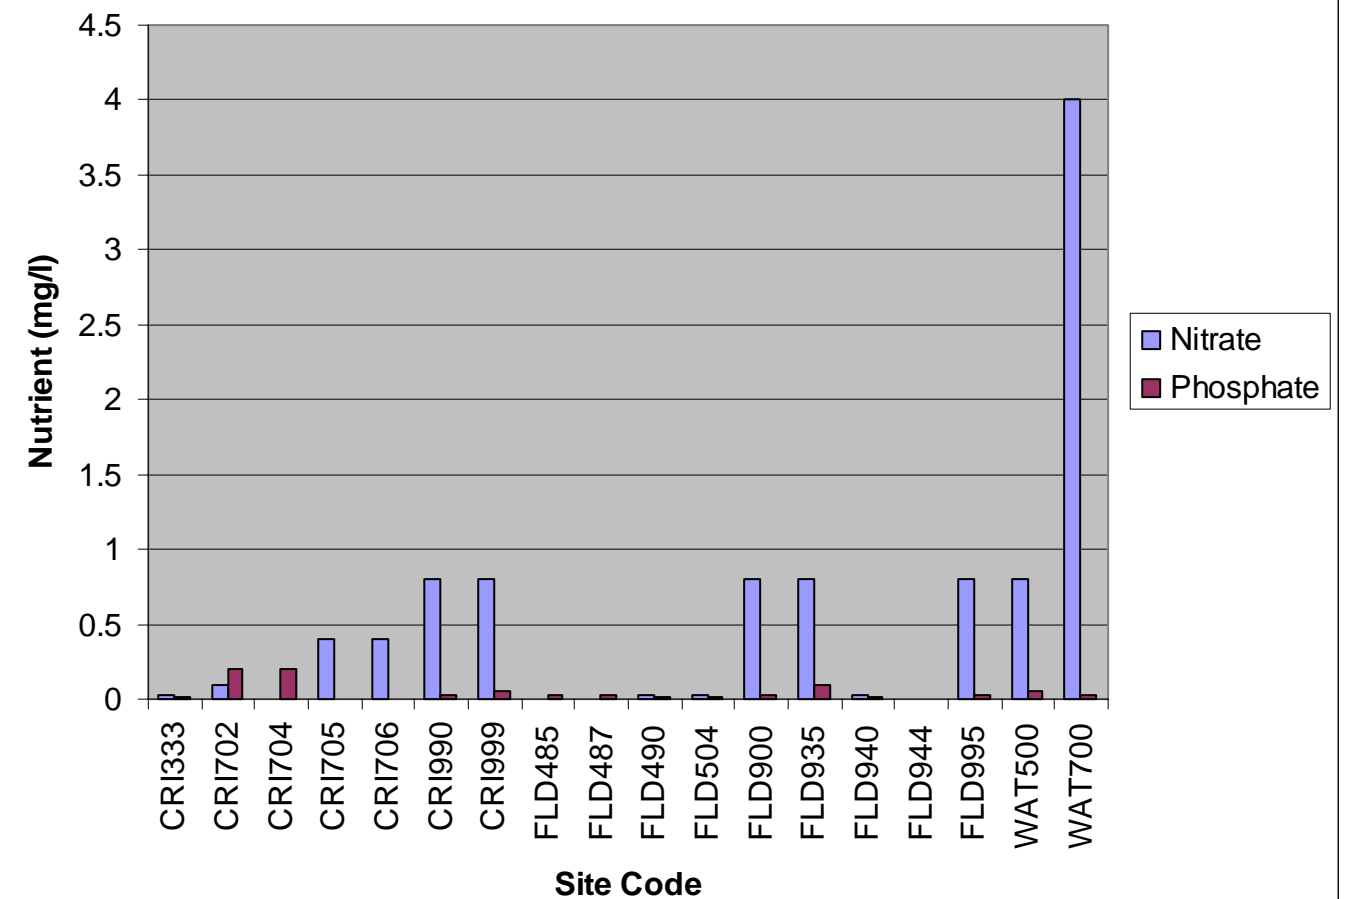
Nutrient Comparison March 2006

The majority of the phosphate levels were low with only 2 of the 15 sites having levels that may be of concern, although having said that they were at the low end of this range. The nitrate is a slightly different story however. Most of the sites had levels that might indicate possible problems, with one site (WAT700) in particular having a very high 4.0mg/l. Equal highest of any site throughout the entire monitoring program!
