# Onkaparinga Waterwatch Snapshot 6

2006 LOWER ONKAPARINGA sites monitored		
Code	Group Name	Site Description
ONK604	Echunga P.S.	On Strathalbyn Rd where Eastern branch of Echunga Creek crosses
ONK606	Echunga P.S.	Echunga PS grounds, Western branch of Upper Echunga Creek
ONK703	Scott Creek P.S.	Under bridge Scott Creek Rd Nth Woolcock Rd intersection
ONK706	Scott Creek P.S.	Scott Creek next to Kurla Lane Oval
ONK708	Scott Creek P.S.	on Lightburn's property, done by Scott Ck P.S.
ONK710	Scott Creek P.S.	Scott Ck X's Scott Ck Rd, 2km SW of Scott Ck PS.
ONK730	Scott Creek P.S.	Near MacKreath Cottage in NP picnic area, Matthews Rd
ONK740	Scott Creek P.S.	MacKreath Ck bridge Dorset Vale Rd, 1km S Matthews Rd
ONK788	Clarendon P.S.	D/strm Formby rd Bridge after 2 creeks have joined
ONK800	Clarendon P.S.	Clarendon Weir - boat ramp
ONK803	Clarendon P.S.	Clarendon Creek at footbridge next to kindy
ONK809	Clarendon P.S.	Clarendon Creek mouth, down side of main road

*Lower Onkaparinga catchment*  
 Incorporating: Kangarilla Creek, Clarendon Creek and main Onkaparinga channel

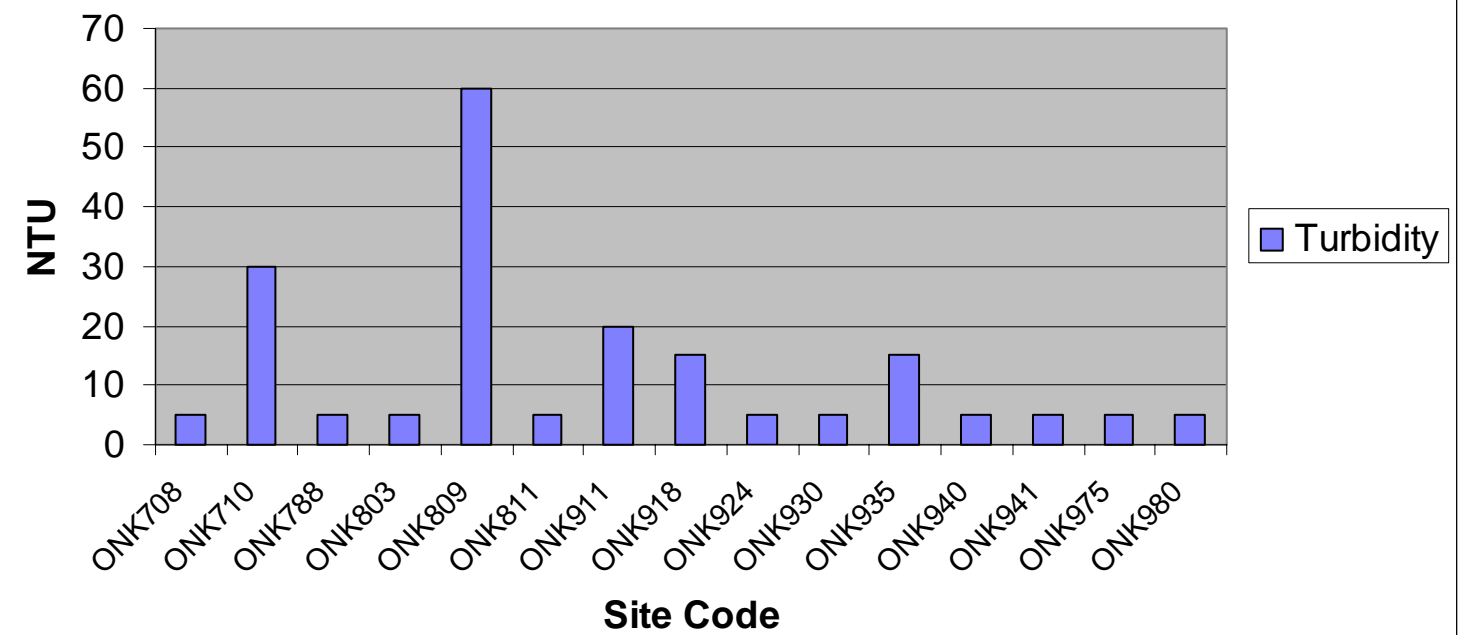
**Turbidity Comparison October 2006**

The majority of sites had turbidity readings low enough to be considered 'good'. The exception being ONK809 with its elevated turbidity reading resulting in a poor water quality rating.
