# Onkaparinga Waterwatch Snapshot 6

Northern Coastal catchments  
Incorporating: Waterfall Creek, Field River,  
Christie Creek catchments

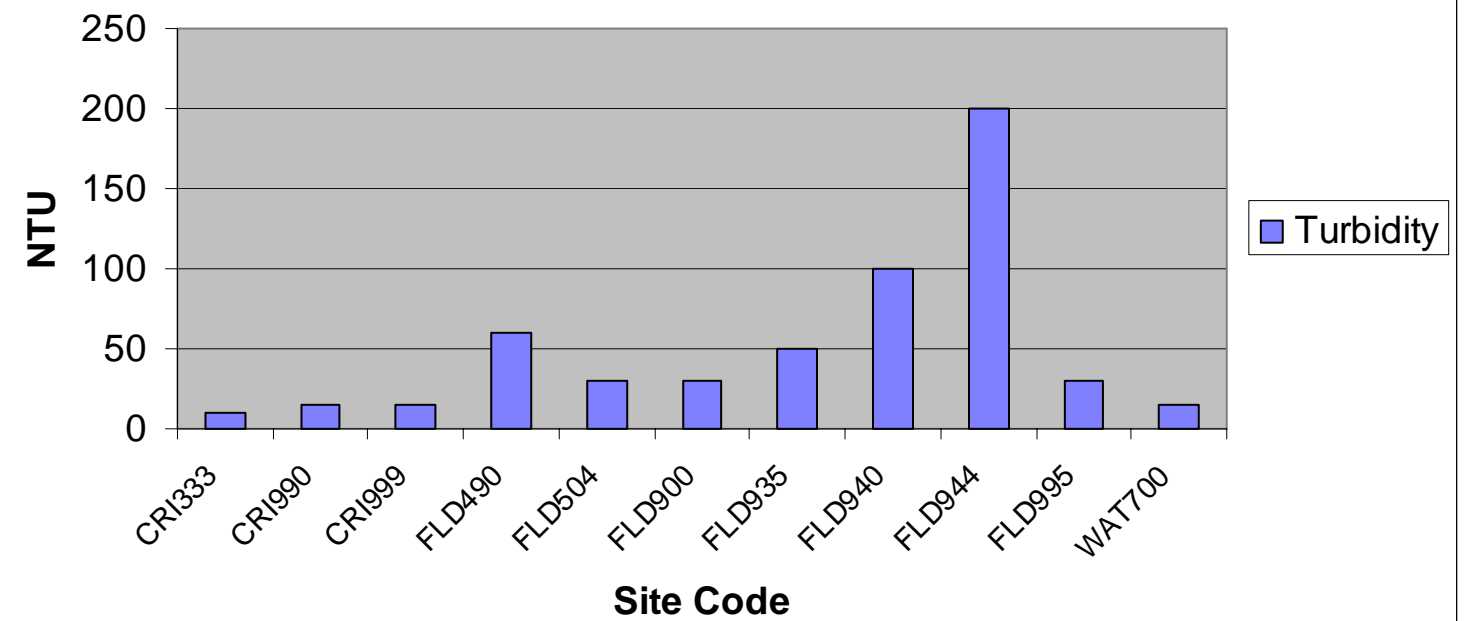
**Turbidity Comparison October 2006**

Turbidity levels at a number of sites are very high this month. FLD940 & FLD944 in particular are extremely high! Overall there is an even mix of poor sites, possible problem sites and good sites.
