Onkaparinga Waterwatch Snapshot 6

Upper Onkaparinga catchment Incorporating: Charleston, Balhannah, Inverbrackie, Spoehr, Western Branch

Turbidity Comparison October 2006

Table of results October 2006

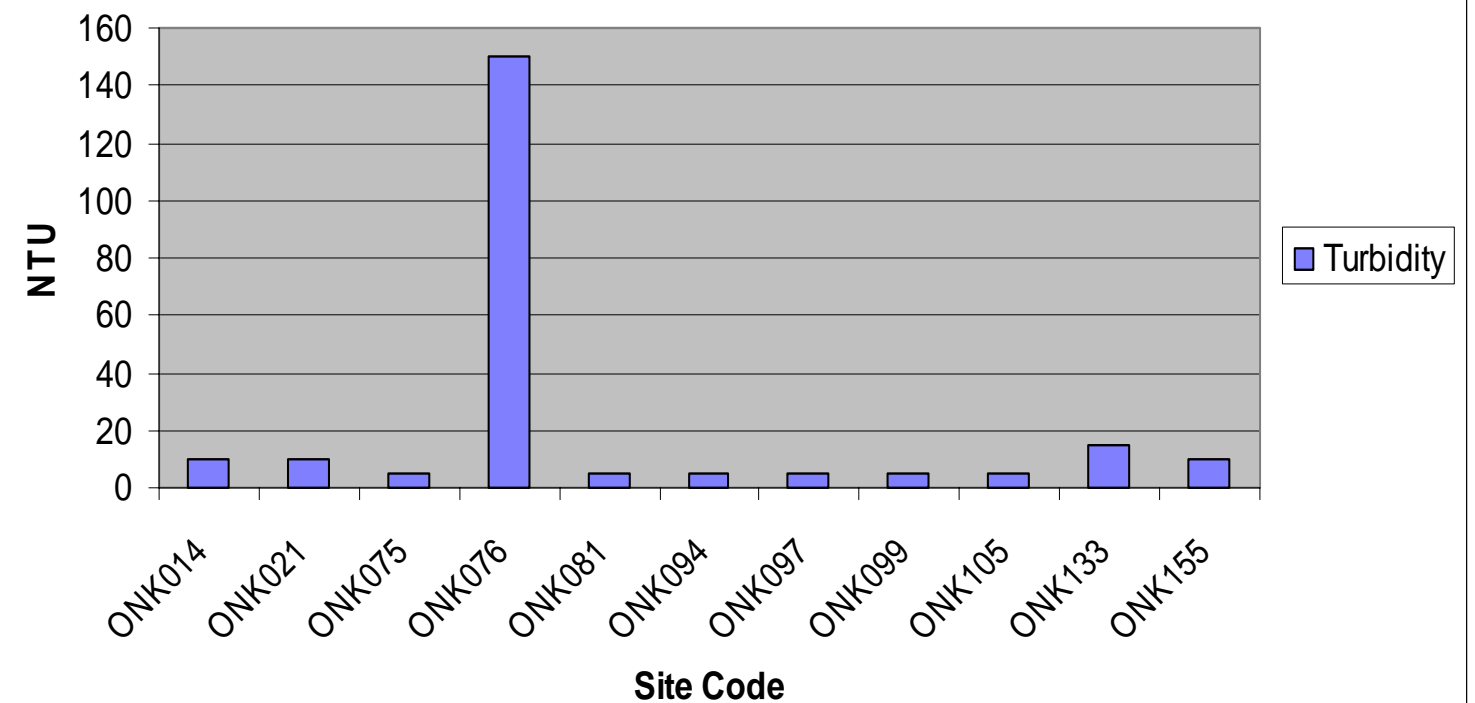
Turbidity results this month for all but one site are excellent. ONK076 being the exception. It recorded a very poor 150NTU reading - well in excess of what is considered acceptable. This site has had extremely high results in the past that have been a result of building development just upstream!
